FOURTH ENDORSEMENT on VF-121 AAR ser 6-58 concerning TV-2 BUNO 136834
accident occurring 22 September 1958, pilot (b) (6)

From: Chief, Bureau of Aeronautics
To: Chief of Naval Operations
Via: Commander, U. S. Naval Aviation Safety Center
Subj: VF-121 AAR ser 6-58

THIRD ENDORSEMENT on VF-121 AAR ser 6-58 concerning TV-2 BUNO 136834
accident occurring 22 September 1958, pilot (b) (6)

SECOND ENDORSEMENT on VF-121 AAR Serial 6-58 concerning TV-2, BuNo
136834, accident occurring 22 September 1958, Pilot (b) (6)

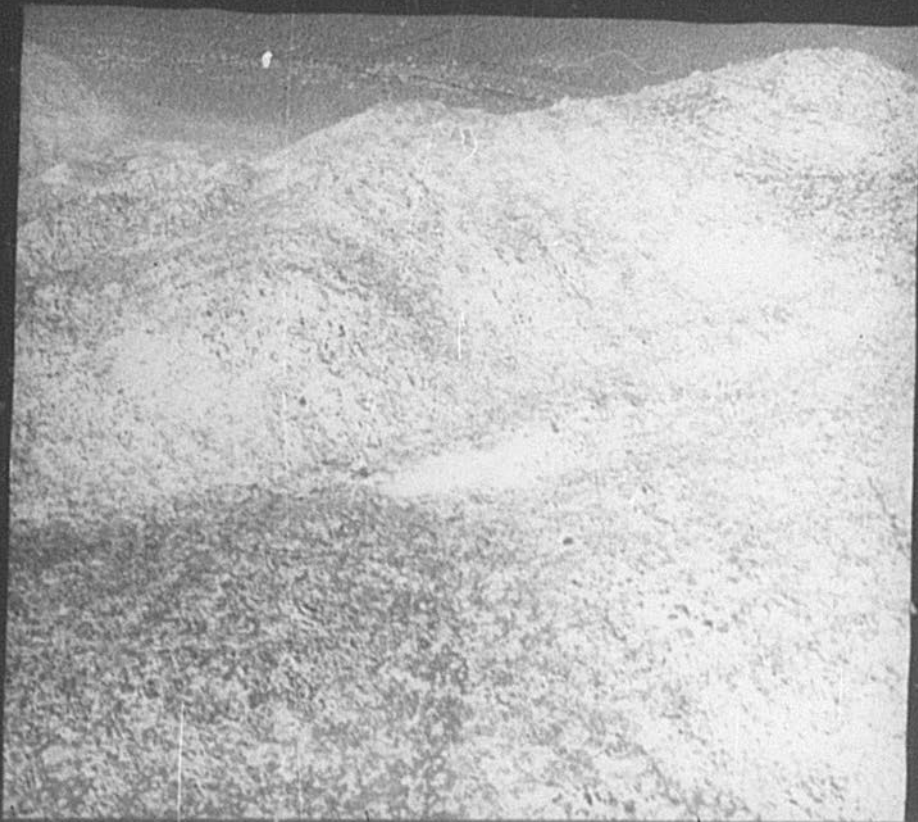
ENCLOSURE 1B VF-121 AAR 6-58

CLOSE UP AERIAL PHOTO OF CRASH SCENE. Initial impact to the left of
burned area. Fire result of impact.

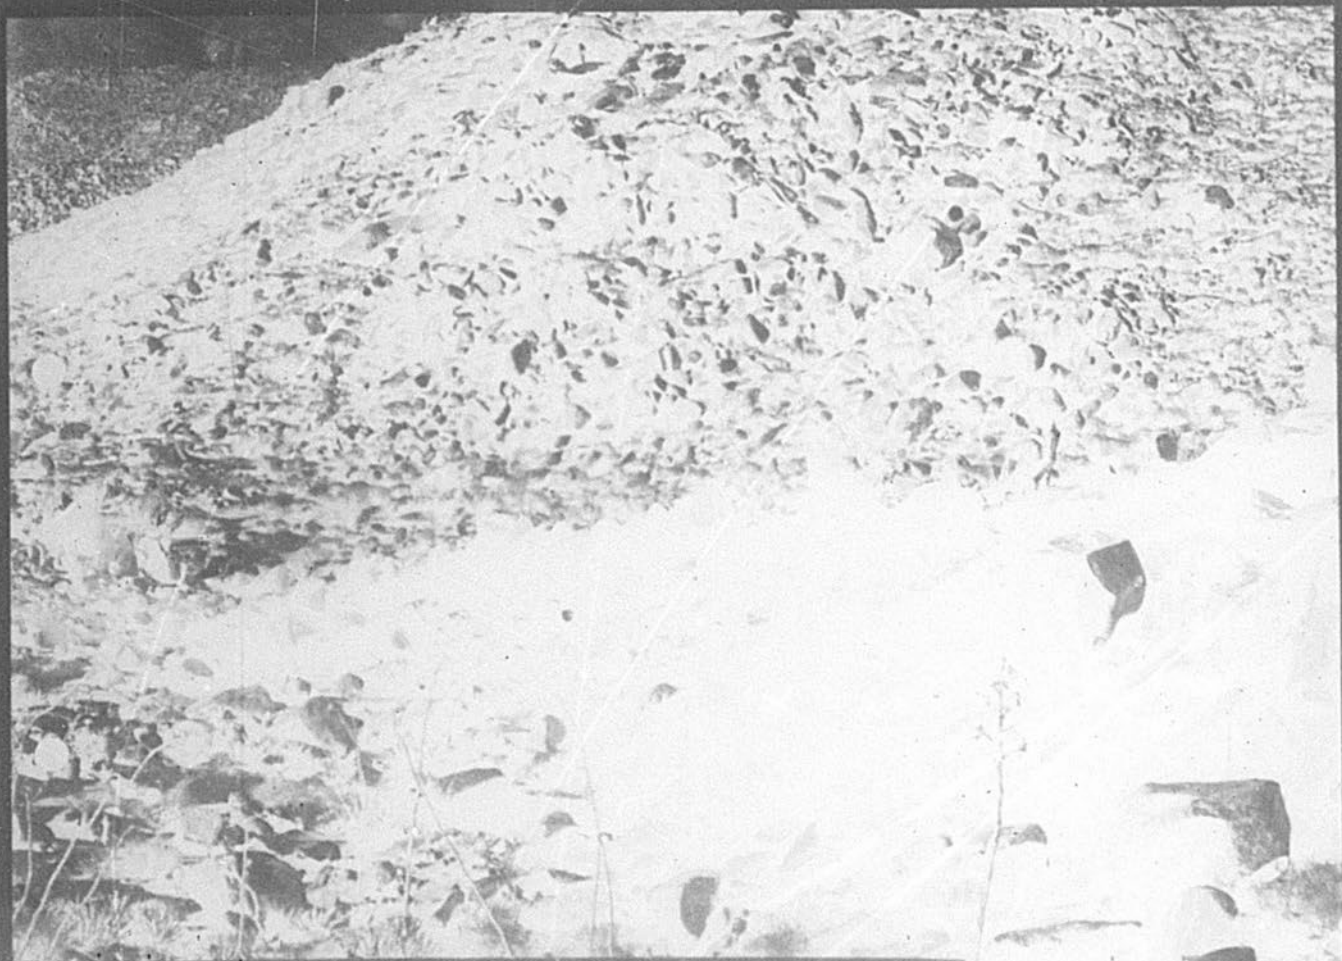
ENCLOSURE 10 VF-121 AAR 6-58

IMPACT AREA OF CRASH. Note initial impact to the left, empennage and final position right center, clamshell nose section door in foreground.
